Modifications to the Precipitator Girder Blower System
for Solving Design Inadequacies

Presented to
the Industrial Management Faculty
University of Southern Indiana
Evansville, Indiana

In Partial Fulfillment
of the Requirements for the Degree
Master of Science in Industrial Management

May 1996

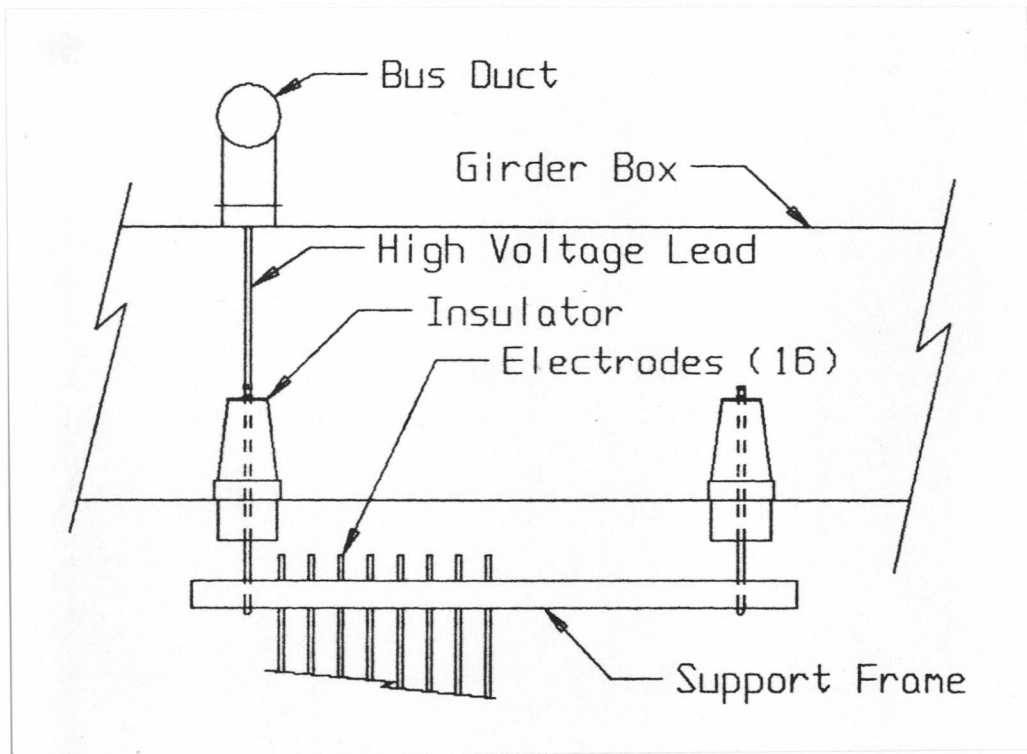
Figure 5. Electrode Support Frame.

The electrodes in each field are supported by a rectangular frame constructed of 8" steel channels (Figure 5.) Each of the four corners is then supported by a 1.875" diameter support pipe. The support pipe penetrates the ESP roof and passes through a porcelain insulator where it is secured with a nut. The electrodes hang inside of this frame. A high voltage lead is then connected between the TR and one of the support pipes to supply the voltage to all electrodes.

This construction technique is prone to grounding out the electrode voltage. It is possible for the flyash to accumulate between a support pipe and the ESP roof penetration allowing the electricity from the field to flow through the buildup of flyash to the ESP casing. Therefore, a small amount of purge air is continuously blown through holes in a metal cap on top of the insulators to keep flyash from accumulating around the support pipes. This purge air is supplied by the girder blower system.

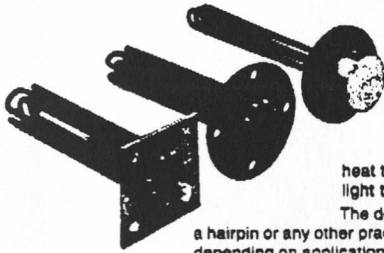
NON-ASA SIZE FLANGED IMMERSION HEATERS

TEMPO introduces Non-ASA size FLANGE IMMERSION heaters, providing an economical alternative to more expensive SCREW PLUG and pressure rated FLANGE IMMERSION heaters. For heating air, degreasing solutions,

heat transfer fluids, water and water solutions and light to heavy oils.
