### **USI Campus Trail Safety Upgrades**

Isaac Hoesli, Manufacturing Engineering Technology  
MFET 491 – Senior Design  
Spring 2025

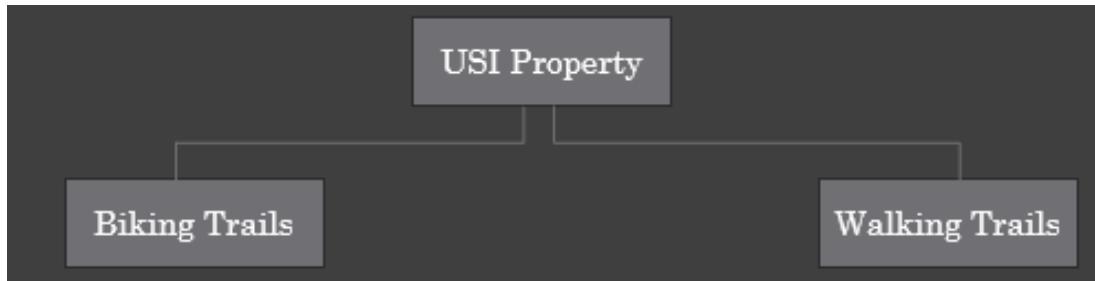
*Figure 4: System Hierarchy*

When looking at the system hierarchy of this project, it starts at the level of the USI property and can then be divided into the biking trails and the walking trails. There are four different walking trails located here on campus. These trails are the Bent Twig Trails, the Disc Golf Trails, the USI-Burdette Trail and the South Trails. There are also 3 different biking trails located here on campus. These trails are known as the Mountain Bike Loop Trail, the Mountain Bike Connector Trail, and the Mountain Bike Flow Trails. This system hierarchy can be found in Figure 4: System Hierarchy.

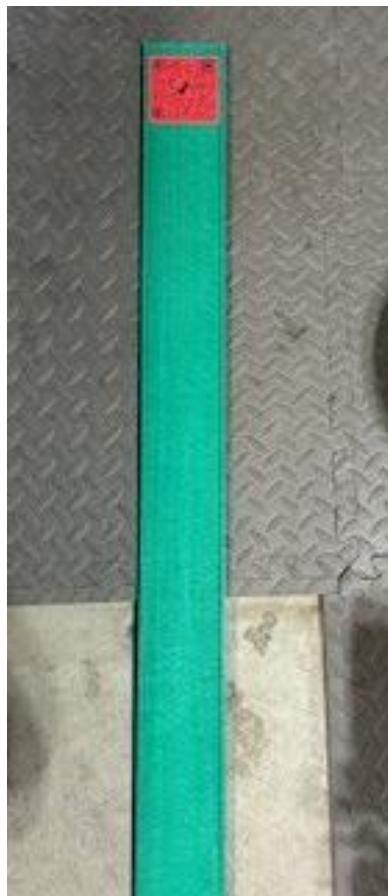
*Figure 11: Old Distance Marker Design*

The original distance marker design included the QR code sticker at the top of the stake followed by the distance sticker below it. This distance marker also only had one QR code on it since it was designed before the idea of two separate QR codes was implemented. The old distance marker is pictured in the image below. This distance marker had the QR code at the top and the distance would go below it however it was not finished due to the design being changed while making it.
