Lidding Web Alignment

Process Improvement of Blister Packaging at AstraZeneca Joshua Feil, BSMFE

> ENGR 491 – Senior Design Spring 2025

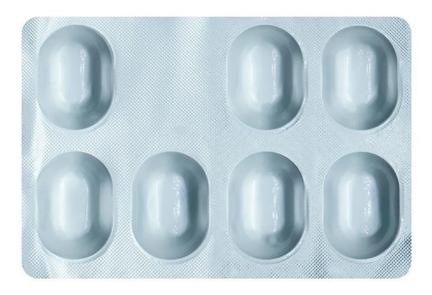
Figure 1: Blister Card

With a focus on improving the blister packaging process, this process must first be understood. A blister card, displayed in Figure 1, consists of an aluminum forming material with pockets to be filled with tablets, and an aluminum lidding material to cover the tablets. The lidding material is typically printed with product and market specific artwork for identification.

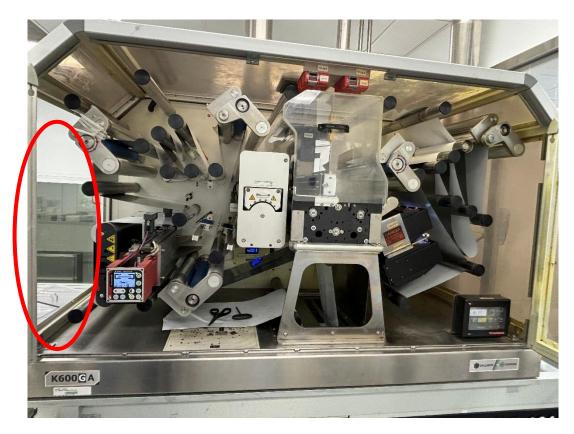
Figure 12: Lidding Printer Available Space Option for Alignment Device

Additionally, the setup of the lidding printer and the web itself was considered in obtaining the desired alignment device. After learning the general footprint of the device, a location was chosen where it could fit within the lidding printer system. Referencing Figure 12 below and after many careful measurements, the circled area on the left side of lidding printer was found to be the only viable location to add an alignment device. On the right side of the machine, there is not enough space to fit the alignment device within the guarding of the machine, and there is not enough space beyond the guarding due to the window enclosing the room only a few inches outside the machine. While there is enough physical space above the machine, it is not a viable option because it is approximately 11 feet above the ground, so it would be extremely difficult to service the system. Any space under the lidding printer would require cutting into the support structure of the lidding printer and would also interfere with the stretching station below. The area on the left side of the printer was carefully discovered to be the only viable space for the alignment device. It is also ideal that the web is nearest to being transported into the stretching station and then sealing from this area where web alignment correction will occur. With this knowledge, the general web path and direction through the alignment device was determined so that the device could be properly configured.

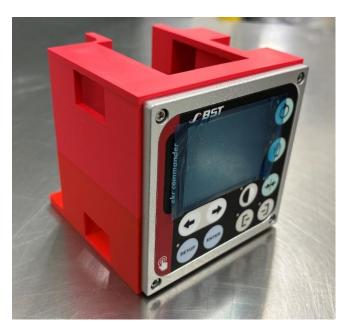
Figure 26: Controller Mounted Inside Housing

One iteration of the design was initially printed as a prototype to ensure correct fitting due to the low cost of 3D printing with PLA. The prototype was found to work fairly well with only minor adjustments of dimensions. The main design change that was made was adding a chamfer to give some room to help the controller fit easier into the housing when inserting it. A final housing was then 3D printed to use for production and the controller put into place as seen in Figure 26 below.
